Fundamental Investigation of Diamond Cutting of Micro V-Shaped Grooves on a Polycrystalline Soft-Brittle Material

Weihai Huang and Jiwang Yan *

Citation: Huang, W.; Yan, J. Fundamental Investigation of Diamond Cutting of Micro V-Shaped Grooves on a Polycrystalline Soft-Brittle Material. *J. Manuf. Mater. Process.* **2021**, *5*, 17. <https://doi.org/10.3390/jmmp5010017>

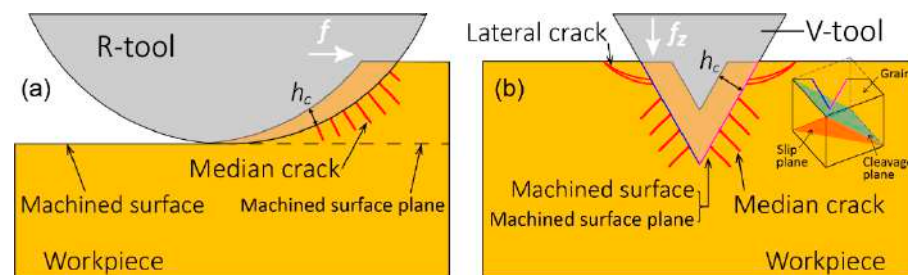
Figure 1. Machining models of (a) flat surface cutting using a round-nosed tool; (b) V-shaped groove cutting using a V-shaped tool.

- (1) The conventional ductile-regime machining model is not applicable to cutting of V-shaped grooves. It is well known that in cutting of flat surfaces, crack-free machined surface can be generated even if the cracks occur during cutting process, as long as median cracks do not propagate to below the machined surface plane [16], as illustrated in Figure 1a. However, when cutting V-shaped grooves, if cracks are produced, the cracks will remain in the machined surface without being removed, as illustrated in Figure 1b. Thus, to achieve crack-free machined surface, the initiation of cracks must be completely suppressed.

- (2) High stress concentration occurs at the apex of groove edge. Existing research on machining V-shaped grooves has reported that high-stress region is located at the apex of groove edge [17,18]. Owing to the low fracture toughness of brittle materials, lateral cracks are likely to initiate at this region, causing material spalling, as illustrated in Figure 1b.

- (3) The two side surfaces of a V-shaped groove are in different relative positions with respect to the cleavage planes and slip planes of crystal grains, as illustrated in Figure 1b. Therefore, the material removal mechanism of the two sides of a V-shaped groove is likely different.

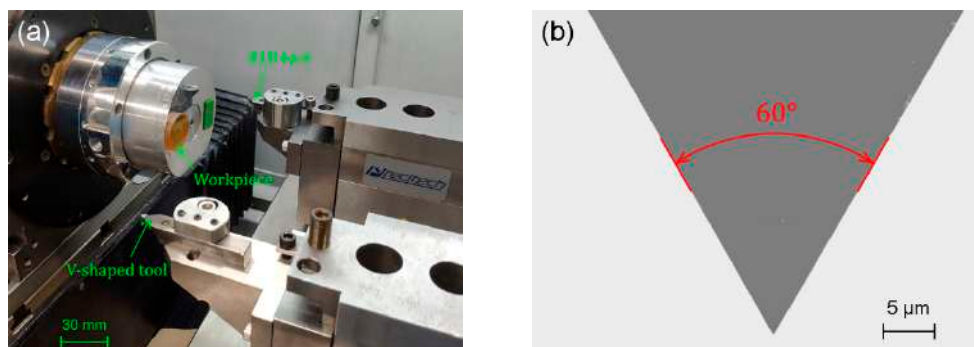
Figure 2. (a) Experimental setup for off-axis diamond cutting of micro V-shaped grooves; (b) SEM image of the diamond tool with an extremely sharpened tool tip.

The micro V-shaped grooves cutting experiment was performed on an ultraprecision lathe Nanoform X (AMETEK Precitech Inc., Keene, NH, USA). Figure 2a shows the experimental setup. The workpiece was fixed on an aluminum block, 20 mm away from the center of spindle. A single-crystal diamond V-shaped tool with an extremely sharpened tool tip and an included angle of 60° was used, the scanning electron microscope (SEM) image of which is shown in Figure 2b. The rake angle and relief angle of the tool are 0° and 5° , respectively. Before cutting the V-shaped grooves, a pre-cut was performed by a diamond tool with a nose radius of 10 mm (R10 tool) to achieve a flat damage-free surface. To make sure that the coating can tightly adhere to the workpiece surface, and that the coating process can be done in situ, photosensitive resin was chosen as the coating material.

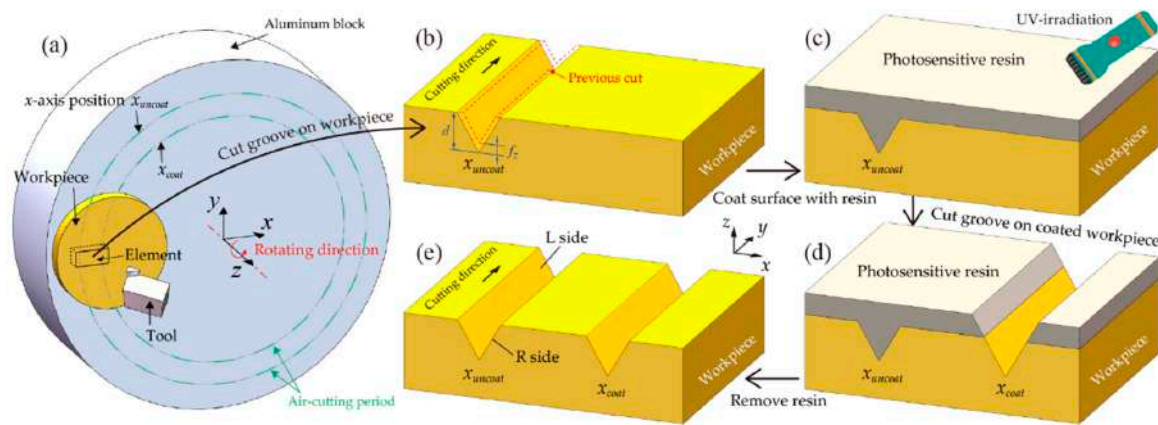
Figure 3. Schematic diagram of the experimental procedure: (a) Off-axis cutting; (b) cutting grooves on uncoated workpiece; (c) coating workpiece surface with photosensitive resin; (d) cutting grooves on coated workpiece; and (e) removing the photosensitive resin. The workpiece shown in Figure 3b–d is a small-area extraction from Figure 3a. For simplicity, the grooves in Figure 3b–d are approximated to be straight, as the curvature is extremely small in such a small area.

Figure 3 schematically shows the experimental procedures. First, V-shaped grooves were cut on the uncoated workpiece, as shown in Figure 3a,b. To cut a V-shaped groove, the tool was incrementally fed along negative z -direction with a distance of f_z during the air-cutting period of each spindle revolution, until the depth of groove d reached the predetermined value. To ensure the feed of Z-slide of machine tools stable during the air-cutting period, the spindle rotation rate was set to 50 rpm. After cutting the V-shaped grooves on the uncoated workpiece, the workpiece surface was coated with photosensitive resin liquid. Followed by irradiating the resin with ultraviolet (UV) light for 30 min, the resin fully cured. Then, the cured resin was flattened and thinned by the R10 tool to a thickness of 20 μm , as illustrated in Figure 3c. Afterwards, other grooves were cut on the coated workpiece under the same condition as that used for cutting the uncoated workpiece, as shown in Figure 3d. Finally, the workpiece was cleaned by acetone in ultrasonic bath to remove the resin, as illustrated in Figure 3e. The machining parameters for the micro V-shaped grooves cutting experiment are summarized in Table 1. Due to the fact that zinc selenide is toxic, and it is difficult to remove chip debris by coolant flushing [22], all experiments were conducted under dry cutting condition, and the cutting chips were collected by vacuum suction during cutting.

It should be pointed out that the cured resin is difficult to completely remove from the surface of the grooves even after cleaning. As shown in Figure 5, all the surfaces of grooves are adhered with resin, especially for the grooves which were cut on the uncoated workpiece (Figure 5c). This is because the grooves cut on the uncoated workpiece were coated by the photosensitive resin liquid during the preparation of coated workpiece (See Figure 3d). The resin flows into the grooves and is difficult to remove.

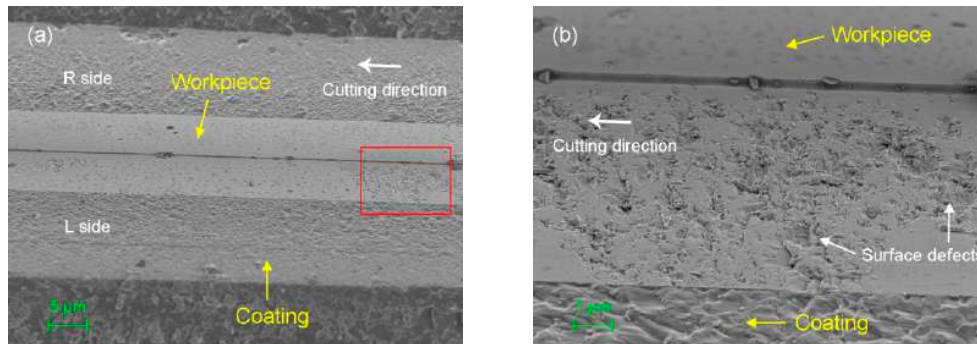
Figure 4. SEM images of the V-shaped groove before removing the resin coating (a) general view; (b) close-up view. (Cutting parameters: $f_z = 10 \text{ nm/rev}$, and $d = 9 \text{ }\mu\text{m}$).

Figure 4 shows the SEM images of typical morphologies of a V-shaped groove before removing the resin coating. It can be clearly observed from Figure 4a that the resin coating had been partially cut with the workpiece material and the remaining part was still adhered tightly to the workpiece surface after cutting. For further observing the surface quality of the machined workpiece and coating layer, as well as the features of workpiece-coating interface, a close-up view of the region marked by a red box in Figure 4a is presented in Figure 4b. On the workpiece surface, there were a lot of defects on the left (L) side of the groove, while an extremely smooth surface was created on the right (R) side of the groove. The difference in formation mechanisms of surface defects on the two sides will be discussed in Section 3.3.

On the other hand, the groove surface of the resin coating showed a homogeneous wave pattern, resulting a slightly rougher surface than the groove surface of the workpiece material. The rough groove surface of the resin coating is thought to be due to the viscoelastic properties of resin and low cutting speed. Since the cured photosensitive resin is a typical polymer material, the fracture strain is very low at room temperature. When the resin is cut at a low cutting speed, fractures occur due to the lack of heat-softening effect at a low cutting temperature [23,24]. Thus, the low fracture strain of the material may cause

an unstable cutting process, resulting in a rough groove surface on the resin coating. The unstable cutting process caused by the resin coating, to some extent, may affect the groove surface quality of the workpiece material.

As for the grooves cut on the coated workpiece (Figure 5d–f), the spalling and cracks at the groove edge were effectively suppressed by the resin coating. The maximum width of the spalling was $\sim 0.18 \text{ }\mu\text{m}$, which was much less than that on the uncoated workpiece. In addition, the surface of the grooves also became smoother. The improvement of surface integrity in V-shaped grooves by using resin coating was verified. In Figure 5e, it is worth noting that there are some striped features on the R side of the groove. This may be caused by the tool chatter that occurred during cutting the resin coating, which has a low fracture strain, as discussed in Figure 4b.

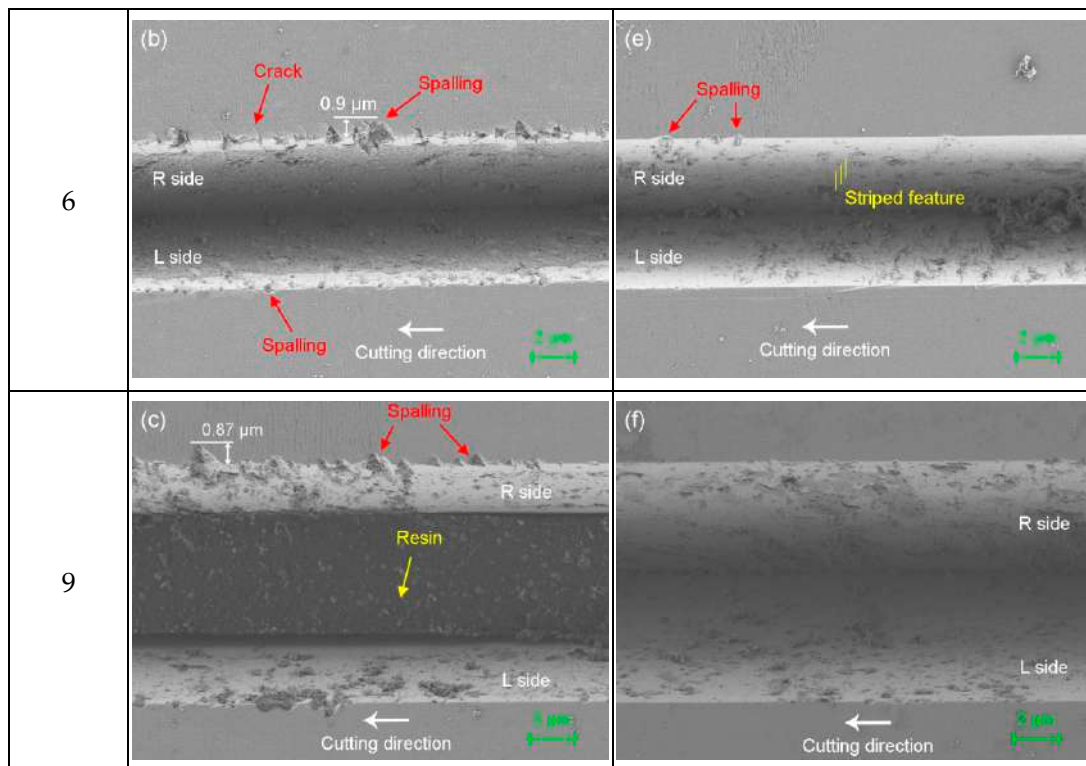
Figure 5. SEM images of the V-shaped grooves after removing the resin coating (all grooves were cut at $f_z = 10$ nm/rev).

Figure 5 shows SEM images of the V-shaped grooves after removing the resin coating. For the grooves cut on the uncoated workpiece (Figure 5a–c), there were considerable spalling and cracks at the groove edge, although the extent of the damage to the L side and R side of the grooves were different. The maximum crack with a width of $0.9 \text{ }\mu\text{m}$ was observed in the groove whose depth was $6 \text{ }\mu\text{m}$, as shown in Figure 5b. However, it seems that the extent of the defects at the groove edge is not related to the depth of groove. Similar defects can also be observed in the grooves with depth of $1 \text{ }\mu\text{m}$ and $9 \text{ }\mu\text{m}$ shown in Figure 5a,c, respectively. Compared with the edge of the groove, the surface of the grooves obtained a better surface quality, having less defects. This indicates that in the cutting of V-shaped grooves on soft-brittle materials, the edges of the grooves are easily fractured, even if the groove surfaces are removed in a ductile mode.

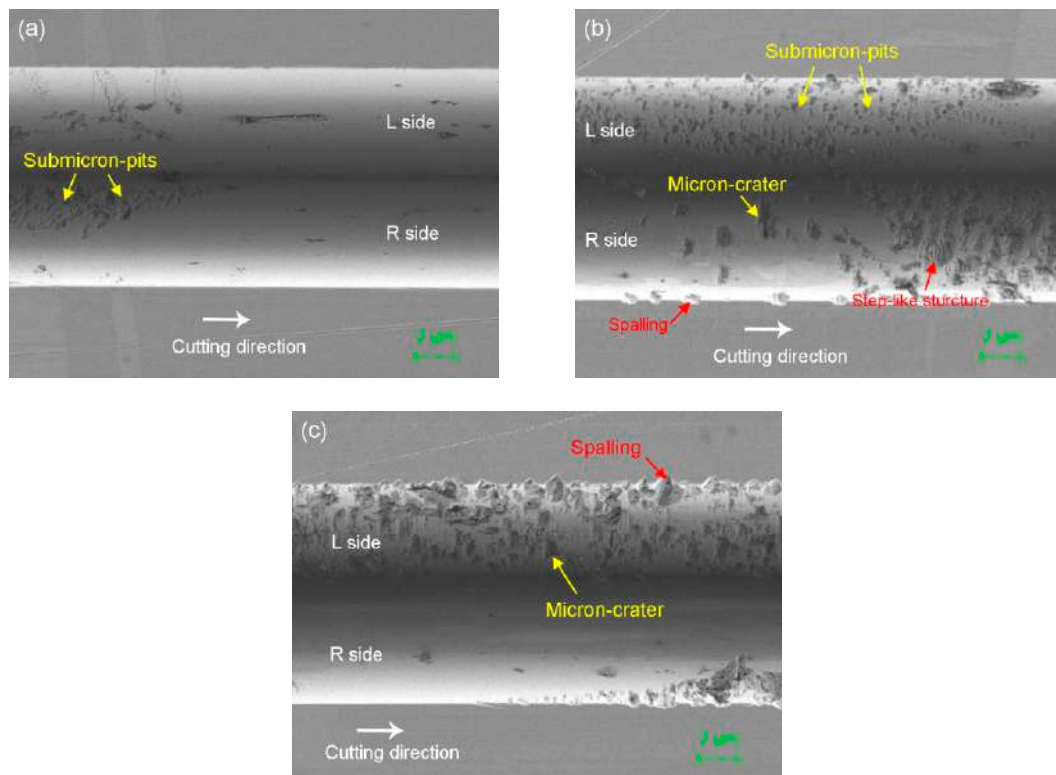
Figure 6. SEM images of V-shaped grooves cut at different feed rates: (a) 20 nm/rev; (b) 40 nm/rev; (c) 60 nm/rev.

Figure 6 shows SEM images of V-shaped grooves cut on the resin coated workpiece at different feed rates f_z . When the feed rate was 20 nm/rev, the edge of the groove was intact, although some defects were generated on the groove surface, as shown in Figure 6a. Those defects consisted of dense pits with a submicron scale. By increasing the feed rate to 40 nm/rev, craters with micron scale were observed on the R side surface of the groove, as shown in Figure 6b. In the micro craters, there is a stepped structure that is vertical to the cutting direction. Such stepped structures are the result of crack propagation, which happened along two cleavage planes that are perpendicular to each other [15,25]. However, on the L side surface of the groove, submicron-pits were observed, which were similar to the submicron-pits shown in Figure 6a. In addition, the spalling occurred at the edge of the groove when the surface defect was close to the edge, although the workpiece was coated with resin. At the feed rate of 60 nm/rev, as shown in Figure 6c, severe damage with micron-craters occurred on the L side surface of the groove and consequently caused the spalling at the edge of the groove. On the other hand, a better surface integrity was produced for the R side surface than the L side surface.

It can be concluded from the above results that when the feed rate is small, the defects that appear as the submicron-pits may occur on the groove surface. However, if the feed rate is increased, two kinds of surface defects, including submicron-pits and micron-craters, can be generated on the groove surface. The spalling at the edge of the groove is also likely to occur.

It is worth noting that even at the same feed rate and the same side of the groove, the grains of different crystal orientations show different surface features, as shown in Figure 6a. In Figure 6b,c, the L side surface and the R side surface of the groove within one grain also show different features. From these facts one may infer that the distribution and morphology of defects are closely related to the crystallographic orientation of the grains and the angle of groove surface. This issue will be discussed further in the next section.

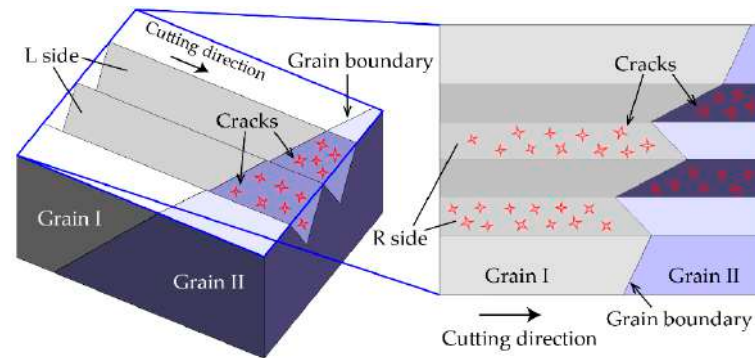
Figure 7. Schematic diagram of double-groove cutting experiment.

To investigate the formation mechanism of surface defects in the grooving process, a double-groove cutting experiment was conducted on the coated workpiece, as illustrated in Figure 7. Two grooves that are parallel and close to each other were cut at the same feed rate of 20 nm/rev. In this case, if the two grooves are through the same crystal grain, the features of the machined surface in the two grooves should be the same because the cutting conditions, including the grain orientation, cutting direction, and feed rate, for the two grooves are exactly the same. For example, as shown in Figure 7, in grain I, if the cracks appear on the R side of one groove, then cracks should also appear on the R side of the other groove. Similarly, in grain II, if the cracks appear on the L side of one groove, then cracks should also appear on the L side of the other groove.

Figure 8 shows the SEM image of a typical area covering the double grooves taken in In-lens Duo mode, which enables both In-lens SE (secondary electrons) and BSE (backscattered electrons) detectors for high-resolution topographical imaging of surfaces, to distinguish where the grain boundaries are. Along the direction perpendicular to the cutting direction, grain boundaries make up many zigzag shapes. It is supposed that each zigzag shape corresponds to a grain boundary, as schematically illustrated in Figure 8b. In addition, in grains with different crystallographic orientations, surface defects appear on different sides of the groove. In the same grain, the L side surface for both groove I and II exhibit the same feature. These results verify the hypothesis of Figure 7.

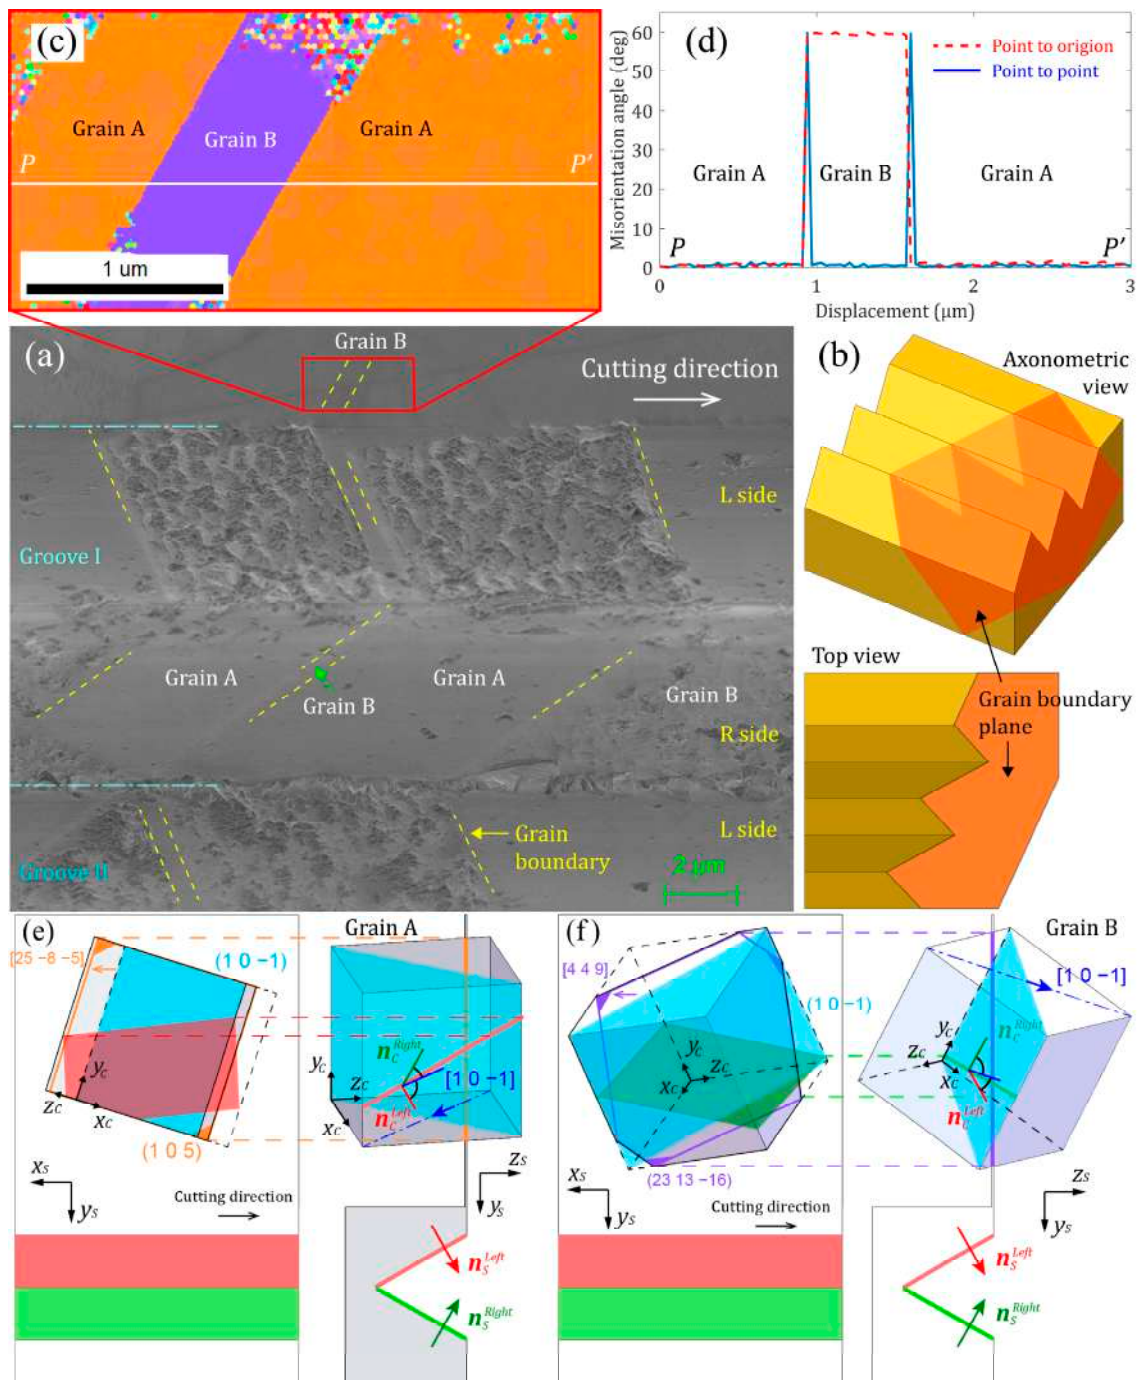
Figure 8. (a) SEM image of a typical area in the double groove taken in Inlens Duo mode; (b) schematic drawings of the grain boundary plane which corresponds to the grain boundary in SEM image; (c) IPF map of the region outlined by red box in SEM image; (d) misorientation angle profile along Line PP' indicated in IPF map. Schematic diagram of the spatial relationship between V-shaped groove and (e) grain A and (f) grain B.

To further understand the dependence of defects formation mechanism on the grain orientation and the direction of side of groove, the crystallographic orientations of grains around the groove were characterized by EBSD analysis. It should be pointed out, however, that the groove surface cannot be directly detected by EBSD, owing to the working principle of EBSD that the target surface must be tilted by an angle of 70° to the orthogonal axis of the incident electron beam, and then EBSD detector receives the back scattered electron in an approximately horizontal direction [26]. Therefore, the crystallographic orientation of the workpiece surface next to the groove was characterized, as outlined by a red box in Figure 8a. The inverse pole figure (IPF) map of the corresponding region is presented in Figure 8b. It shows that there are two grains (A and B) with different crystallographic orientations. The orientations of the Gains A and B represented by Miller index are (1 0 5) [25-8-5] and (23 13-16) [4 4 9], respectively. The misorientation angle between grains A and B along Line PP' was extracted from the IPF map, as plotted in Figure 8c. The misorientation angle between the two grains is 60° , which indicates that grains A and B are twin pairs having a coherent twin boundary around $\langle 111 \rangle$ [27]. From the above analysis, it can be inferred that the grains located within the SEM image area are dominated by grain A and grain B (Figure 8a).

According to the geometry of the V-shaped tool, the normal vector of L side and R side surface of the groove in sample coordinate system (SCS) are $\mathbf{n}_S^{Left} = \left[0, \frac{\sqrt{3}}{2}, \frac{1}{2}\right]$ and $\mathbf{n}_S^{Right} = \left[0, -\frac{\sqrt{3}}{2}, \frac{1}{2}\right]$, respectively, as illustrated in Figure 8e,f. The relationship between the crystal coordinate system and the sample coordinate system is given by:

Table 2 lists the angle between the most favorable cleavage plane and the groove surface in grains A and B, respectively. In grain A, the cleavage plane makes an angle of 86.5° to the L side surface of the groove, and 60.5° to the R side surface of the groove. Then, it was observed from Figure 8a that the surface defects occurred on the L side surface of the groove in grain A, rather than the R side surface of the groove. On the other hand, in grain B, the cleavage plane makes an angle of 44.8° to the L side surface of the groove, and 79.4° to the R side surface of the groove. As seen from Figure 8a, in grain B, the surface defects

occurred on the R side surface of the groove, rather than the L side surface. These results reveal that if the groove surfaces are approximately perpendicular to the grain’s cleavage plane, surface defects are very easily to occur.

It is worth noting that in Figure 8a, on the R side surface of the groove I, the grain B with a narrow area (pointed by the green arrow) exhibits a crack-free surface, which is different from the grain B with a large area on its right side. In addition, by observing the SEM image shown in Figure 9, which was captured by HE-SE (high efficiency secondary electron) detector, narrow areas without cracks are found in the damaged surfaces in both grains A and B. These narrow areas always occur at the beginning of cutting of a new grain, as indicated by the green lines in Figure 9. This indicates that the grain boundary can block the stress spreading into the adjoining twin, and the cracks are initiated when the accumulated stress concentration exceeds a critical point. It is likewise observed from Figure 9 that in the groove I, the extent of damage on the L side surface of grain A is more severe than that on the R side surface of grain B. This might be attributed to the fact that the most favorable cleavage plane of grain A becomes almost perpendicular to the groove surface, while this is not the case for grain B.

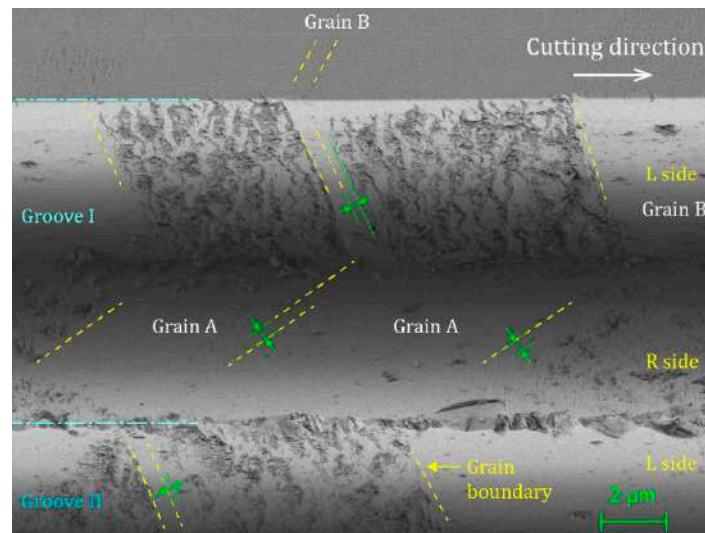
Figure 9. SEM image of the same region as Figure 8a by HE-SE detector.

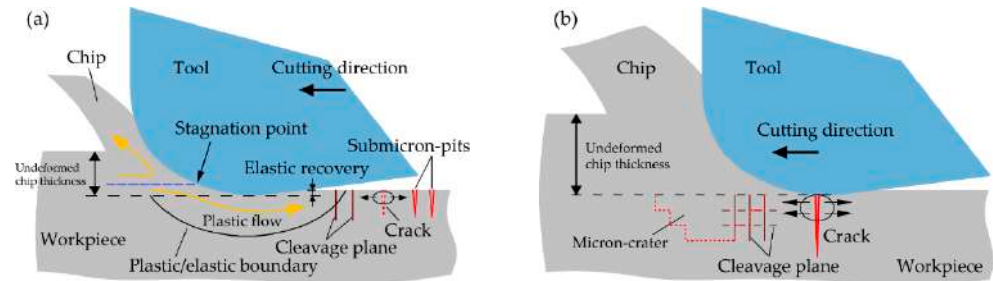
Figure 10. Schematic model for (a) formation of submicron-pits; (b) formation of micron-crater.

Figure 10 shows schematic models of the formation mechanism of surface defects during the microgrooving process. When the tool feed rate is small, the undeformed chip thickness is also small, as shown in Figure 10a. Thus, the plowing effect is significant. The part of material below the segment point will not be separated from the workpiece [29]. Rather, the material is pressed by the tool and passes through below the tool tip, resulting in a plastic/elastic deformation layer. If this layer is formed in a grain in which the

cleavage plane is vertical to the groove surface, tearing effects along the cleavage planes will occur during the elastic recovery of machined surface. Consequently, submicron-pits will generate on the groove surface.

When the feed rate is large, the undeformed chip thickness also becomes large, as shown in Figure 10b. Under this condition, a relatively high tensile stress will be generated in material along the cutting direction [25]. If such a stress state happens in a grain in which the cleavage plane is vertical to both cutting direction and groove surface, cracks can easily occur beneath the tool and propagate along both horizontal cleavage plane and vertical cleavage plane, which causes severe defects as micron-craters on the groove surface. However, if such a stress state happens in a grain in which the cleavage plane is not vertical to the groove surface, but crosses the groove surface at a large angle, cracks may still occur due to the high tensile stresses, resulting in the surface defects as submicron-pits.

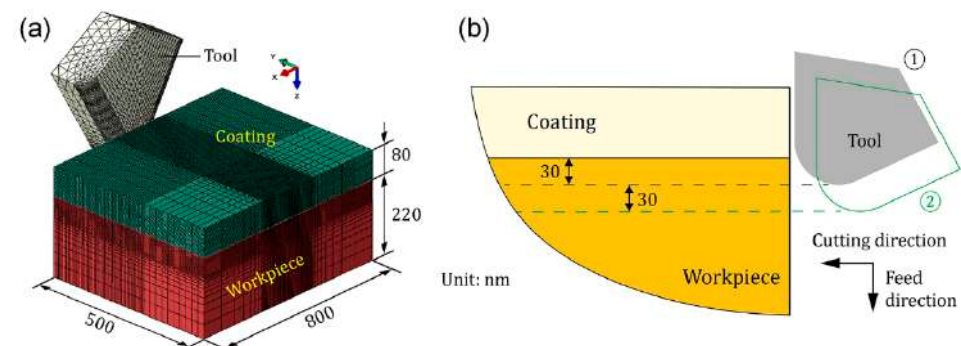
Figure 11. (a) 3D simulation model of microgrooving process; (b) schematic of simulation configuration showing two paths of cutting tool.

To clarify the reason that coating is effective in preventing initiation of cracks at the edge of grooves, the stress distribution of microgrooving process was investigated by finite element method (FEM) simulation using a commercially available software ABAQUS. Figure 11a shows the 3D simulation model of microgrooving process. The size of workpiece and coating were $500 \times 800 \times 220$ nm and $500 \times 800 \times 80$ nm, respectively, which were meshed by 106,400 and 159,600 eight-node linear brick elements (C3D8R). The cutting tool with an edge radius of 40 nm was meshed by quadratic tetrahedral elements (C3D10M) and was set as rigid body due to significantly high hardness of diamond tool compared to *p*-ZnSe. In the simulation configuration, as shown in Figure 11b, first the tool cut into the workpiece at a depth of cut of 30 nm. Then the tool fed 30 nm and cut the workpiece for the second time. The cutting speed was 0.2 m/s.

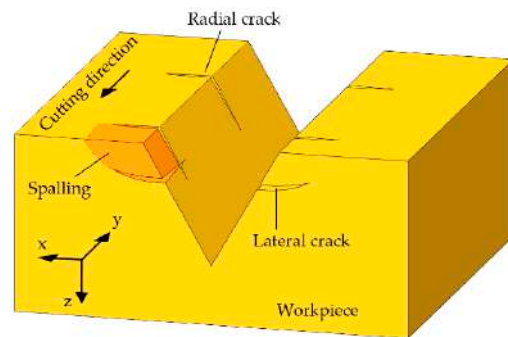
Figure 12. Schematic diagram of crack generation in cutting groove on brittle materials.

It has been widely accepted that the tensile stress is mainly responsible for the crack nucleation during cutting brittle materials. The tensile stresses along the cutting direction and the direction normal to the workpiece surface are responsible for the radial cracks and lateral cracks, respectively. Figure 12 shows a schematic diagram of crack generation in cutting groove on brittle materials. If the radial cracks and lateral cracks intersect with each other, the spalling of material is very likely to occur at the edge of the groove. Therefore, the tensile stresses along the cutting direction and the direction normal to the workpiece surface were examined after completing the simulation of the second cut. Although the simulated stress values in this study may be not quantitatively accurate, the results are adequate to achieve a qualitative comparison.

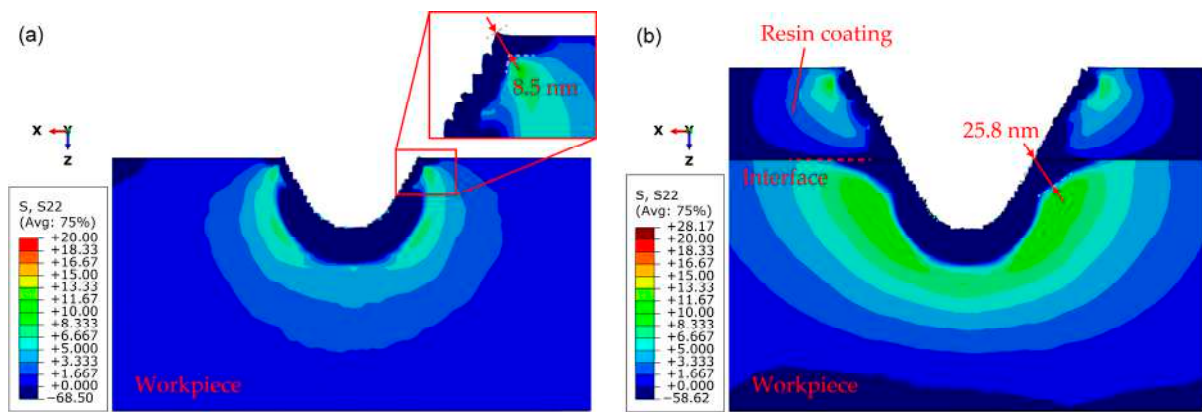
Figure 13. FEM-simulated tensile stress along cutting direction (y -axis direction) in: (a) Uncoated workpiece; (b) coated workpiece.

Figure 13a,b shows simulated distribution of the tensile stress along the cutting direction (σ_y) in uncoated workpiece and coated workpiece, respectively. It can be observed that a thin layer of material near the groove surface is under compressive stress, which is surrounded by a tensile stress field. This stress distribution is similar to that in an indentation test [32]. The pressure-induced densification and shear-induced plastic flow dominate the material in the small contact zone beneath the tool. After the tool passes, elastic recovery of the densified/deformed layer occurs, consequently the tensile stress tends to be enhanced along the boundary of the densified/deformed layer and the bulk, causing crack generation. In the uncoated workpiece, σ_y was concentrated closely to the edge of the groove and was featured by a sharp corner. However, in the coated workpiece, σ_y was distributed relatively farther from the edge of the groove and presented a smooth transition. That is, the compressive/tensile stress boundary near the edge of the groove was an arc without sharp edges and was farther away from the apex of the groove edge. As a result, radial cracks should be less likely to occur at the edge of the groove in the coated workpiece.

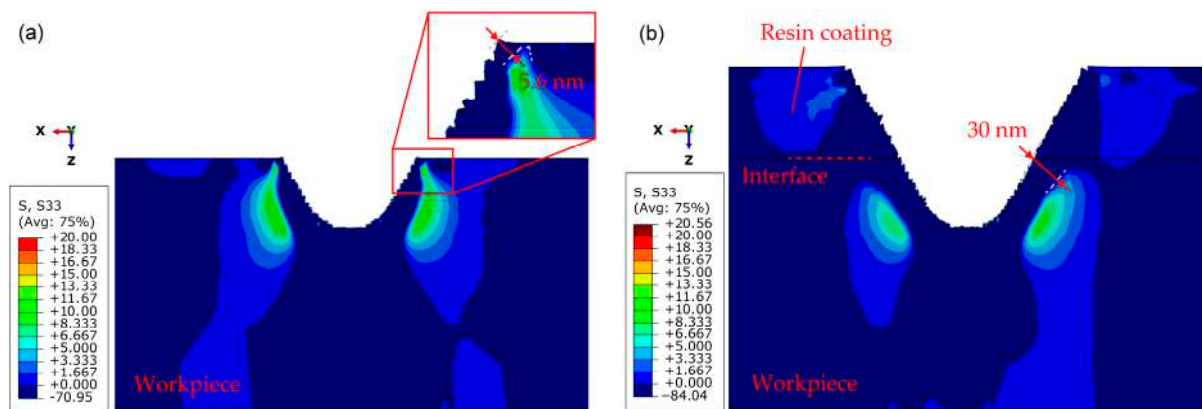
Figure 14. FEM-simulated tensile stress along the direction normal to the workpiece surface (z -axis direction) in: (a) Uncoated workpiece; (b) coated workpiece.

Figure 14a,b shows simulated distribution of the tensile stress along the direction normal to the workpiece surface (σ_z) in uncoated workpiece and coated workpiece, respectively. Similarly, in the uncoated workpiece, the σ_z was distributed very close to both the edge of the groove and the surface of the workpiece. The feature of the stress distribution pattern near the edge of the groove was likewise characterized as a sharp corner. However, in the coated workpiece, the σ_z was distributed relatively far from the edge of the groove and the surface of the workpiece. In addition, the feature of the stress distribution pattern near the edge of the groove presented a smooth transition. Therefore, lateral cracks should be less likely to occur at the edge of the groove in the coated workpiece. Based on the foregoing analysis, it can be concluded that the resin coating was able to make distribution of tensile stresses (both σ_y and σ_z) away from the edge of the groove and the workpiece surface, consequently suppressed brittle fractures at the edge of the groove.
