Towards understanding the ultrasonic vibration-assisted diamond cutting of ZnO crystals: Surface integrity and tool wear mechanism

Weihai Huang , Takeshi Hashimoto, Jiwang Yan

Department of Mechanical Engineering, Faculty of Science and Technology, Keio University, 3-14-1 Hiyoshi, Kohoku-ku, Yokohama 223-8522, Japan

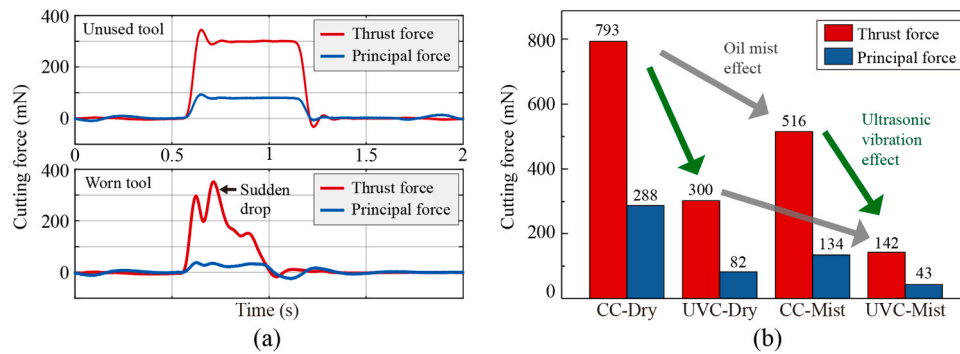
Fig. 8. Cutting forces analysis: (a) typical dynamic force curves during dry cutting under different tool conditions with UVC assistance, (b) comparison of cutting forces obtained during stable cutting under various cutting conditions.

The cutting forces during the ruling experiments conducted under various conditions, i.e., CC and UVC with either dry or oil mist lubrication, were measured. As shown in Fig. 2c, since the tool stops after each cutting pass and returns to the starting point for the next cut, vibrations are generated during the reverse motion, causing fluctuations in the cutting force (Fig. S5). The dynamic force curves for one of the ruling passes during UVC under dry conditions are presented in Fig. 8a. At the beginning of the ruling process, the unused tool produced stable cutting forces, remaining nearly constant throughout most of the cutting process, except during the initial tool-workpiece engagement phase, as shown in the upper part of Fig. 8a. The force result is in accordance with the formation of a smooth machined surface (Fig. 3d). However, in the cutting force curve obtained using the worn tool, sudden drops in thrust force can be observed, as shown in the lower part of Fig. 8a. This may be attributed to material fracture on the machined surface, caused by partial loss of contact between the tool flank face and the workpiece, as evidenced by the severe brittle fracture observed on the machined surface (Fig. 4b), likely resulting from tool edge wear. To evaluate the cutting performance within the effective cutting distance, the stable cutting forces measured in the early stage of the ruling process under various cutting conditions were compared, as shown in Fig. 8b. In all cases, the thrust force was significantly greater than the principal force. With other factors remaining constant, the forces in UVC were lower than those in CC. In addition, the forces under oil mist lubrication were lower than those under dry conditions. Consequently, UVC with oil mist lubrication produced the minimum cutting forces. There may be two reasons for the force reduction measured during UVC. One is that the dynamometer's sampling frequency was lower than the tool vibration frequency, thus the obtained values in UVC represent average cutting forces [26,40]. The other is that vibration enhanced the lubrication effect by forming a lubricating film between the tool and the workpiece via the vibration-induced intermittent tool-workpiece contact.

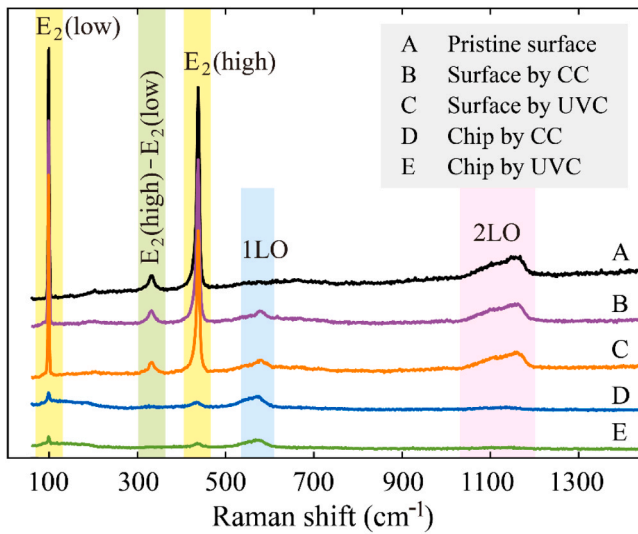
Fig. 9. Comparison of ZnO Raman spectra between the pristine surface, machined surfaces, and collected chips.

and presented in Fig. 9. A spectrum obtained from the pristine surface was also provided for comparison. For the spectrum of the pristine surface, two strong Raman peaks at 99 cm^{-1} and 437 cm^{-1} corresponding to the $E_2(\text{low})$ and $E_2(\text{high})$ modes were observed, which are attributed to the sublattice vibrations of zinc and oxygen, respectively [42]. In addition, two weak peaks were detected near 333 cm^{-1} and 1160 cm^{-1} , representing the $E_2(\text{high})-E_2(\text{low})$ mode and second-order 2LO mode [43]. However, for the machined surfaces produced by both CC and UVC, a new broad peak near 578 cm^{-1} was observed,

corresponding to the overlap of the $A_1(\text{LO})$ and $E_1(\text{LO})$ modes, which is assigned collectively to the 1LO mode. This suggests that the cutting process induced defects in machined ZnO, including lattice disorder and oxygen vacancies [42,44]. For the spectra of the cutting chips, the intensities of the $E_2(\text{low})$ and $E_2(\text{high})$ peaks were significantly decreased compared to those of the pristine and machined surfaces, while the 1LO peak maintained a similar intensity to that observed on the machined surfaces, indicating a deterioration in the crystalline quality of the wurtzite-structured ZnO [45]. The Raman spectra of the chips are akin to those of the rock salt phase of ZnO, which is transformed from the wurtzite phase under a pressure higher than 9 GPa [46]. It should be noted that the phase transformation observed in the UVC process is induced by the instantaneous cutting force at the moment of tool-workpiece contact, which, according to simulation studies [47], is believed to be equivalent to that in conventional cutting, rather than by the measured average cutting force.

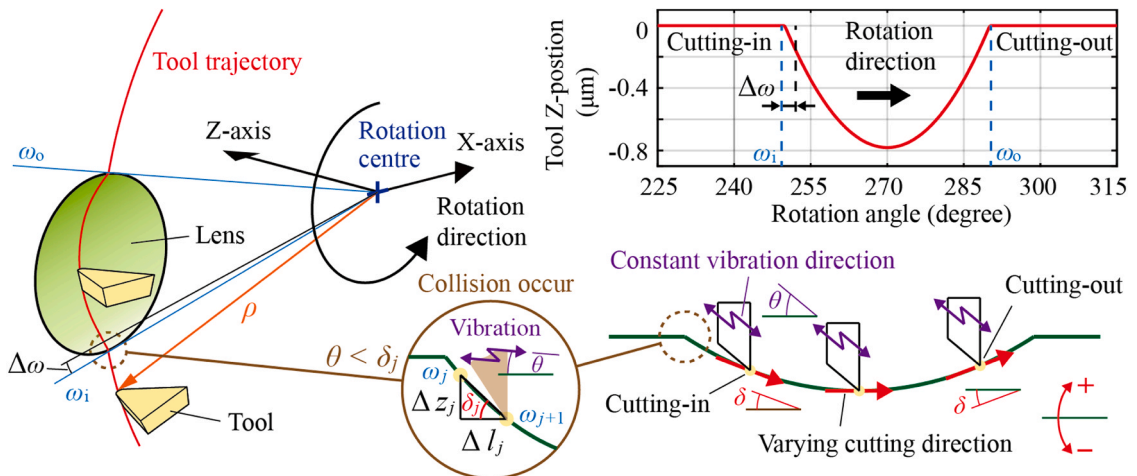
Fig. 15. Schematic illustrating the tool trajectory during lens machining using a slow tool servo, and the direction of ultrasonic vibration of the tool relative to the lens surface.

Unlike cutting a flat surface with ultrasonic vibration assistance, machining a curved surface may result in interference between the tool flank and the machined surface during the backward stroke of the vibration cycle. Specifically, the collision of the tool flank with the machined surface will occur if the inclination angle of the tool vibration (θ) is less than the local slope angle of the curved surface (δ). Therefore, when cutting a concave microlens surface, as shown in Fig. 15, such collisions are more likely to occur during the tool's entry into the surface (cutting-in) rather than during its exit from the surface (cutting-out). Since the inclination angle θ is determined by the ultrasonic vibration unit and is constant at 2° in this study, as described in Fig. 2b, it is

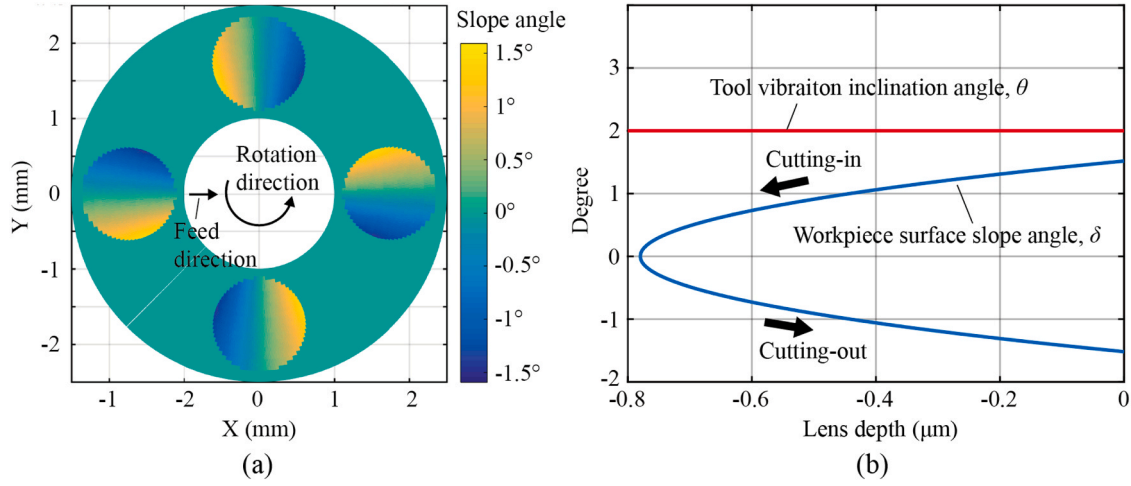
Fig. 16. Illustrations of the microlens surface geometry and the correlation between tool vibration and surface slope: (a) slope angle map of the designed microlens array. (b) relationship between the tool vibration inclination angle and the workpiece surface slope angle at the meridian of a lens.

Fig. 16a presents the slope angle map of the designed microlens array, where each lens has a diameter of $125 \mu\text{m}$ and a radius of curvature of 2.5 mm . Along a circular path concentric with the rotation centre, the slope angle gradually decreases from a positive value to a negative value, corresponding to the tool cutting into and then out of the surface. Furthermore, when viewed from the region where the tool first cuts into the surface, the largest slope angle among all concentric circular paths is observed along the path that intersects the deepest point of the lens, also known as the meridian of the lens.

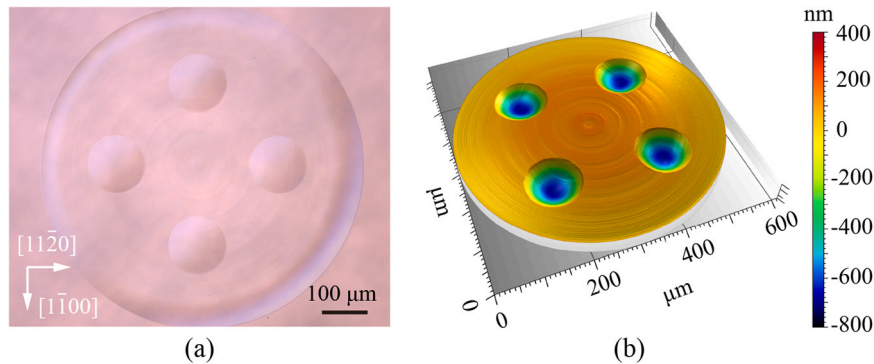
Fig. 17. Machined microlens array using slow tool servo diamond turning combined with ultrasonic vibration assistance under oil mist lubrication conditions: (a) differential interference contrast microscopy image; (b) three-dimensional white light interferometry image.

Fig. 17a shows a differential interference contrast microscopy image of a diamond-turned circular surface, with four microlenses symmetrically positioned along the circumference. The diagonal lines connecting the microlenses align with the $[1-100]$ and $[11-20]$ directions,

respectively. Despite the cutting direction continuously changing relative to the crystal orientation during machining, the diamond-turned flat area exhibited a completely crack-free surface, similar to the initial surface (i.e., the uncut area outside the circular region) prepared by CMP. Moreover, the four microlens areas, where the cutting direction was close to the $[1-100]$ and $[11-20]$ crystallographic directions during machining, also exhibited smooth surfaces. The fracture anisotropy of ZnO was weakened due to the enhanced material plasticity induced by ultrasonic vibration impact (as evidenced by Fig. 12) and the reduced maximum undeformed chip thickness. A three-dimensional white light interferometry image of the diamond-turned circular surface is presented in Fig. 17b. Surface waviness can be observed on the diamond-turned flat area, which may be attributed to unstable temperature conditions that cause the horn of the ultrasonic vibration unit to shrink or expand by several nanometres. Tool wear after microlens array machining was found to be insignificant (Fig. S8).

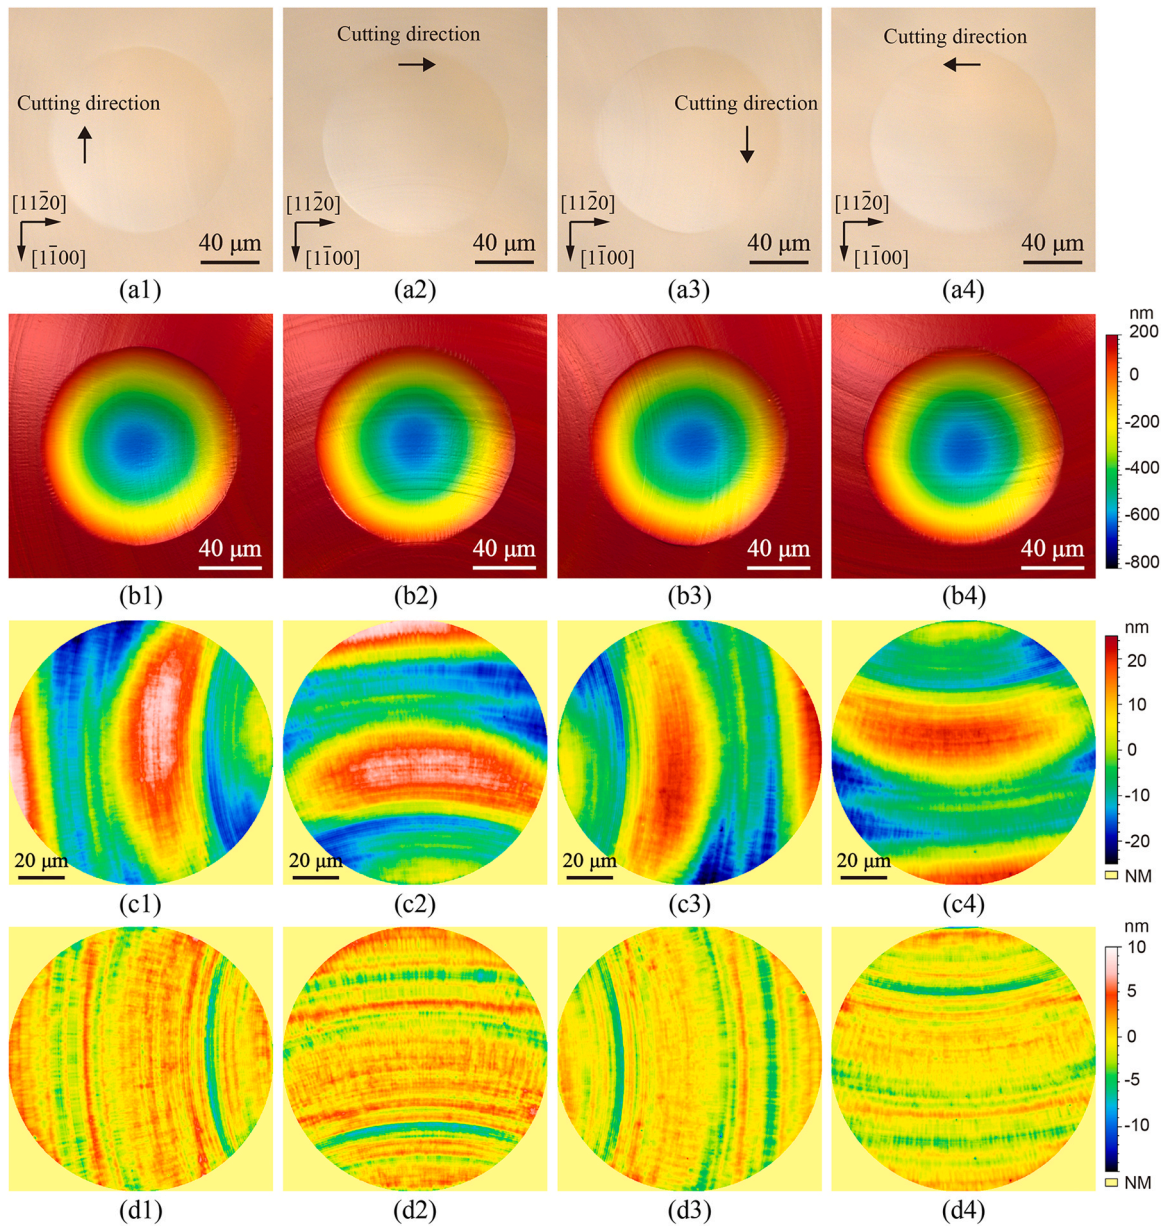
Fig. 18. Detailed views of the four individual microlenses shown in Fig. 17: (a) differential interference contrast microscopy images; (b) three-dimensional white light interferometry images; (c) form error maps by removing a spherical surface having a 2.5 mm radius of curvature from the measured surface shown in (b); (d) surface roughness by applying a Gaussian filter with a cut-off length of 25 μm to the form error maps shown in (c).

shown in Fig. 18. Differential interference contrast microscopy images (Fig. 18a) revealed that the surfaces of all four microlenses were free of cracks. Fig. 18b presents the three-dimensional white light interferometry images. The depths of the four lenses exhibit excellent consistency, measured at $747 \text{ nm} \pm 1.1 \text{ nm}$. The form error maps shown in Fig. 18c were obtained by subtracting a spherical surface having a 2.5 mm radius of curvature from the measured surface topographies presented in Fig. 18b. The peak-to-valley (PV) form errors of the four microlenses were 47.3, 44.6, 48.4, and 47.6 nm, respectively. After applying a Gaussian filter with a cut-off length of $25 \mu\text{m}$ to the form error maps shown in Fig. 18c, the surface roughness was obtained and is presented in Fig. 18d. The results indicate that all four lenses exhibited uniformly high surface quality, with root mean square roughness (Sq) values of 1.9, 2.1, 2.2, and 2.0 nm, respectively. The consistently high-quality surfaces of the lenses confirm that the ultrasonic vibration motion did not interfere with the designed surface structure.
